Irwin Farmstead

Santa Rosa, California

HISTORIC RESOURCE ASSESSMENT

October 2003

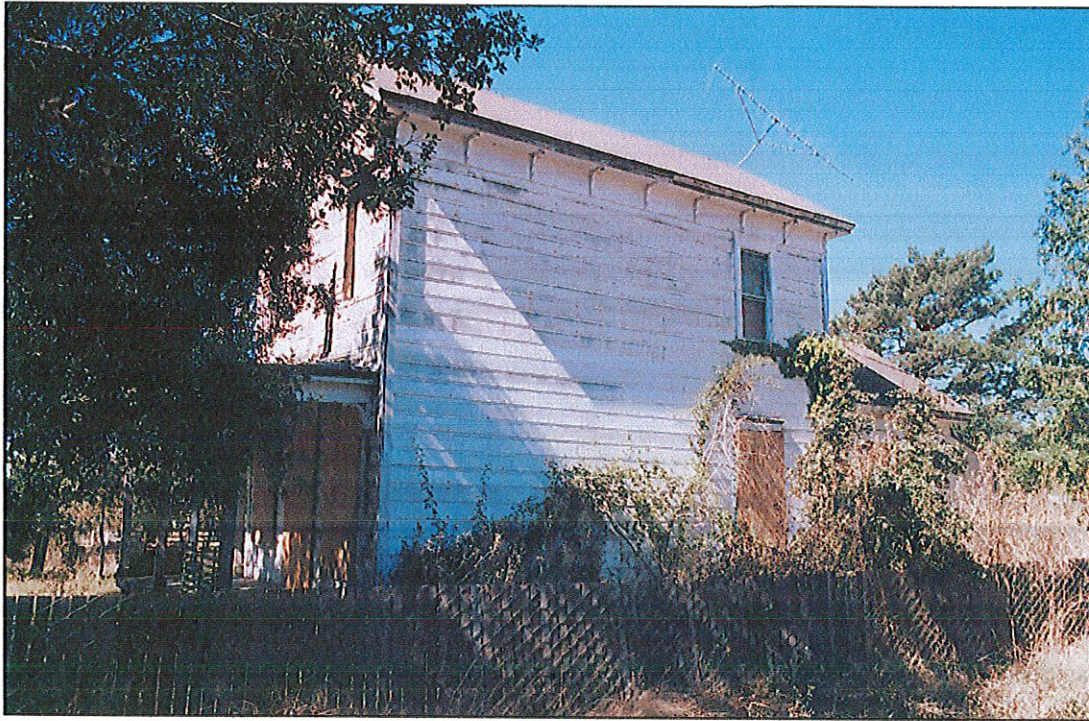
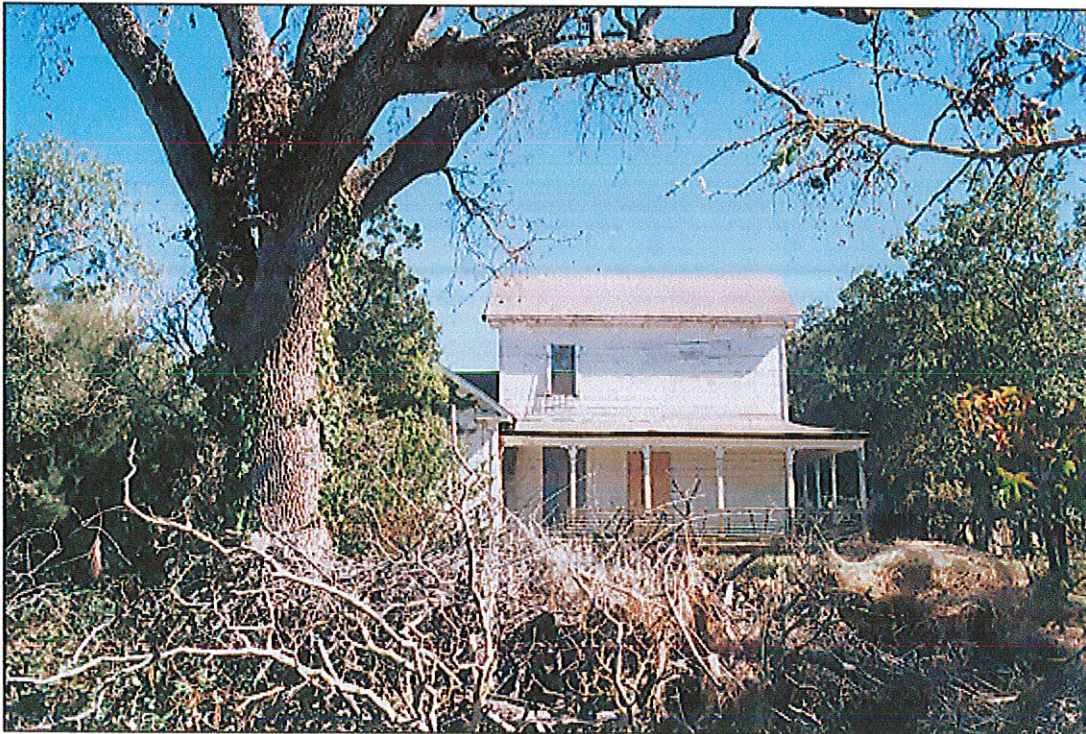
Figure 8: 1898 farmhouse

The side elevations of the main body of the house also feature one-over-one light double-hung windows, placed at north end of the east and west façades. All windows and doors feature wide, molded trim where it has not been removed. The window sash has been replaced with aluminum frame on the upper story in front. Other windows retain their wood frames. A metal plate is affixed to the wall above the second story window to the west.

East façade

West facade

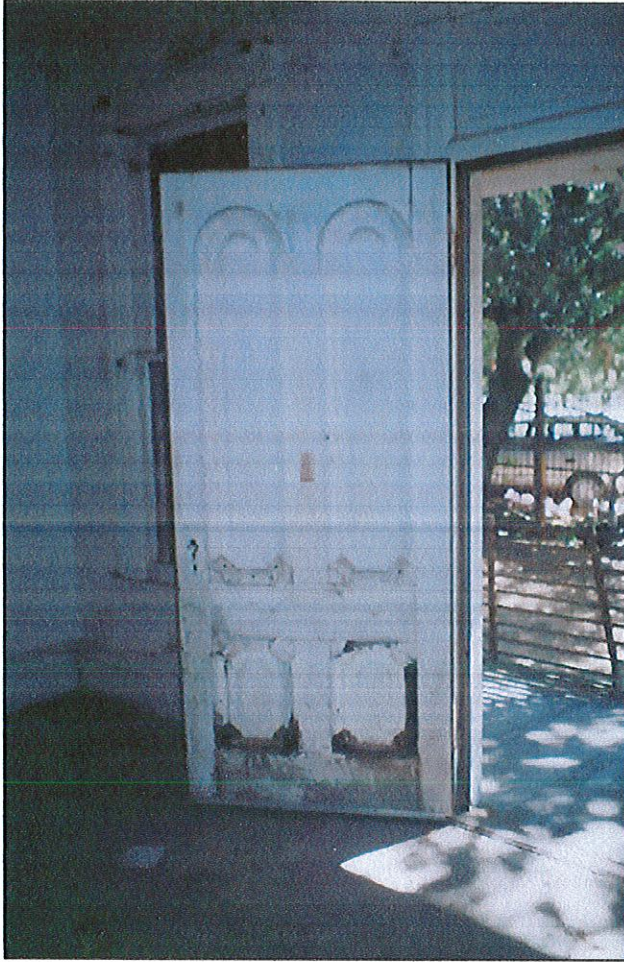
Figure 10: Architectural details

The lintels further extend the line of the tall, narrow windows on the structure to the frieze band. Moldings are elaborate for a house of this type, and constitute one of the character-defining features of the structure. Other character-defining features include the square posts around the porch (one is missing), with their wood bases and capitals of

Paneled door

Brackets

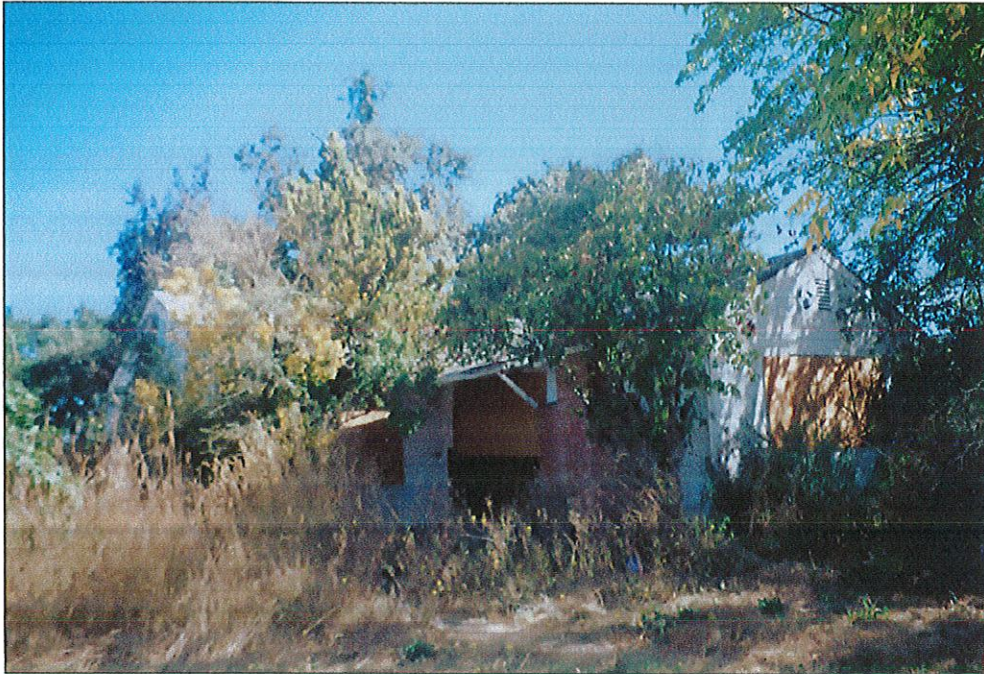
Figure 11: Views of 1951 house

The newer house on the site was built in 1951, according to Assessor records. It is an L-shaped, one-story, wood frame house with gable roofs and an attached, covered carport on the east side. The 'square' footprint of the house is roughly 30' by 30'. A covered entry and patio area is located on the west side of the house. The front portion of the structure was added in 1960, according to Martha Lawson (*interview, October 2003*). Several other additions and alterations to the structure exist, undermining its architectural integrity. It was reportedly damaged in the 1969 earthquake (*Assessor Records, 1973*).

View of house from Kawana Terrace Road

View of house from rear

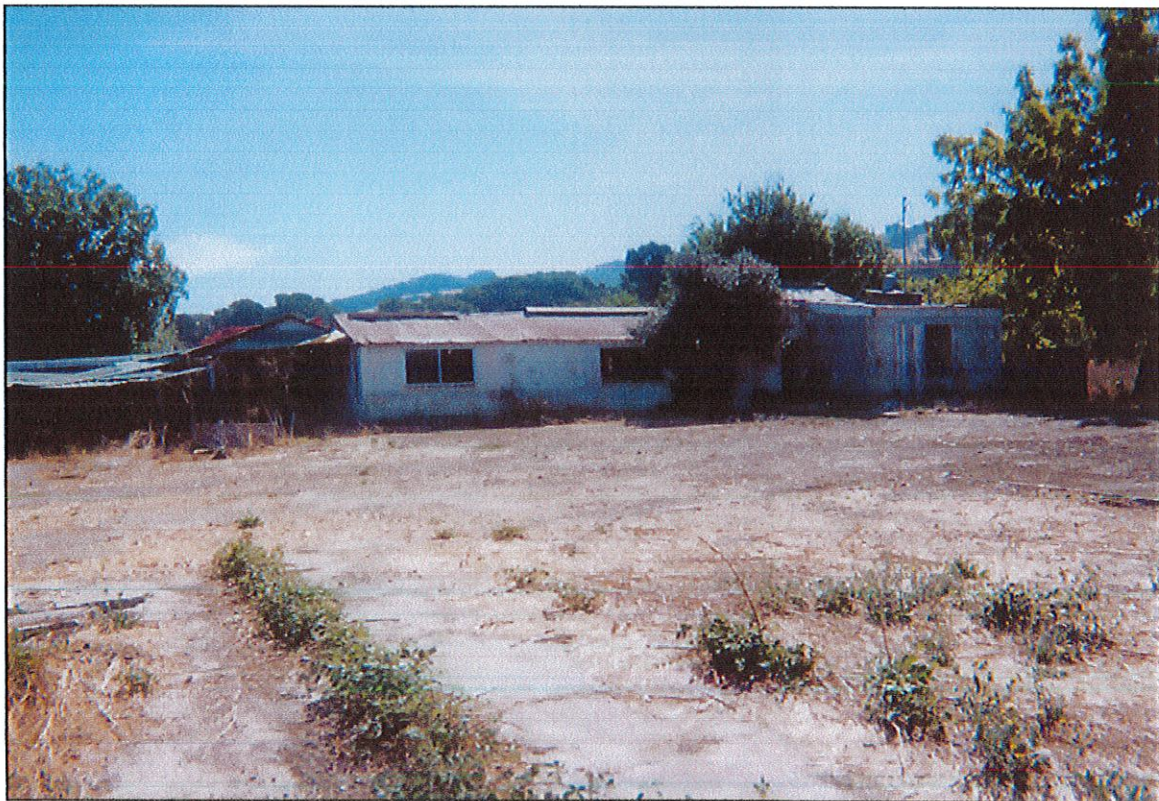
Figure 12: Two views of milking parlor

The Milking Parlor has been added to over time (essentially, what were separate buildings were connected with additions and a covered breezeway). Some portions of the structure are in poor condition, but the interior retains the features that indicate how the structure was used. Cows entered the north end of the structure, which is a series of sheds clad in metal and other various materials today. The central portion contains the milking parlor, which features a wood stanchion in the center along the length of the building, a molded-concrete feed trough along one side, to the west, and the milking area along the other side, to the east. The structure has a concrete slab floor and formed concrete walls. To the south is a concrete milk processing room. A narrow hall with concrete stairs (function unknown) separates the two. Pipes and meters in this hallway show how milk was piped from the milking area to the processing room.

Other interior rooms exist in this barn complex, and it is not clear what they were used for. Overall, the structure is in poor condition. The main function of the barn as a milking parlor, however, is still apparent.

Close-up of milking parlor

View of milking parlor with barn foundation in foreground

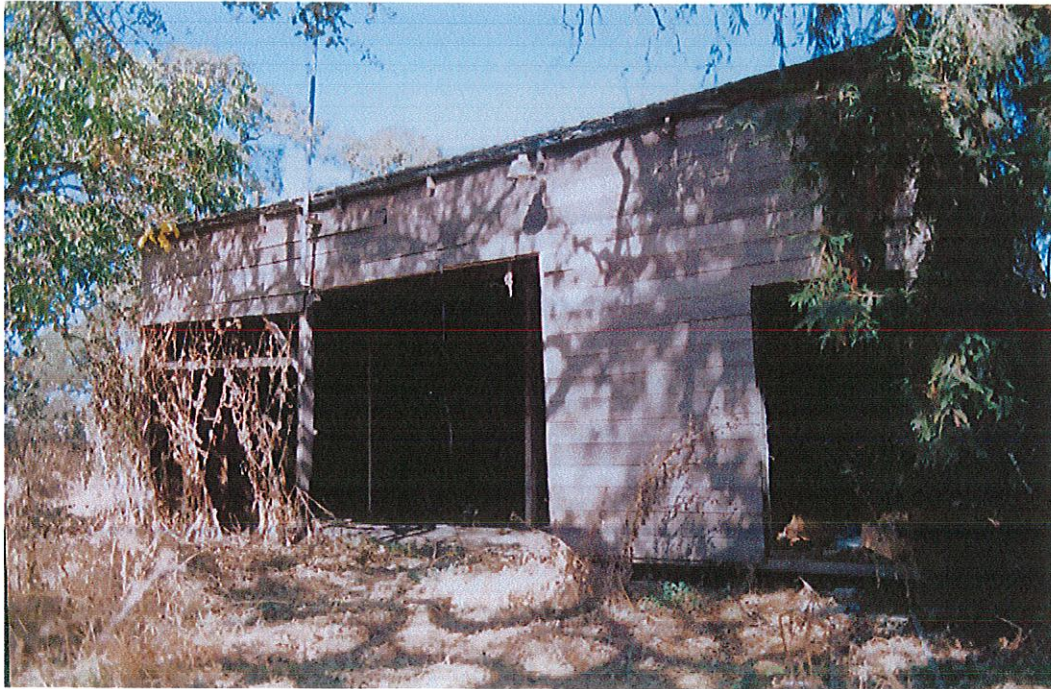
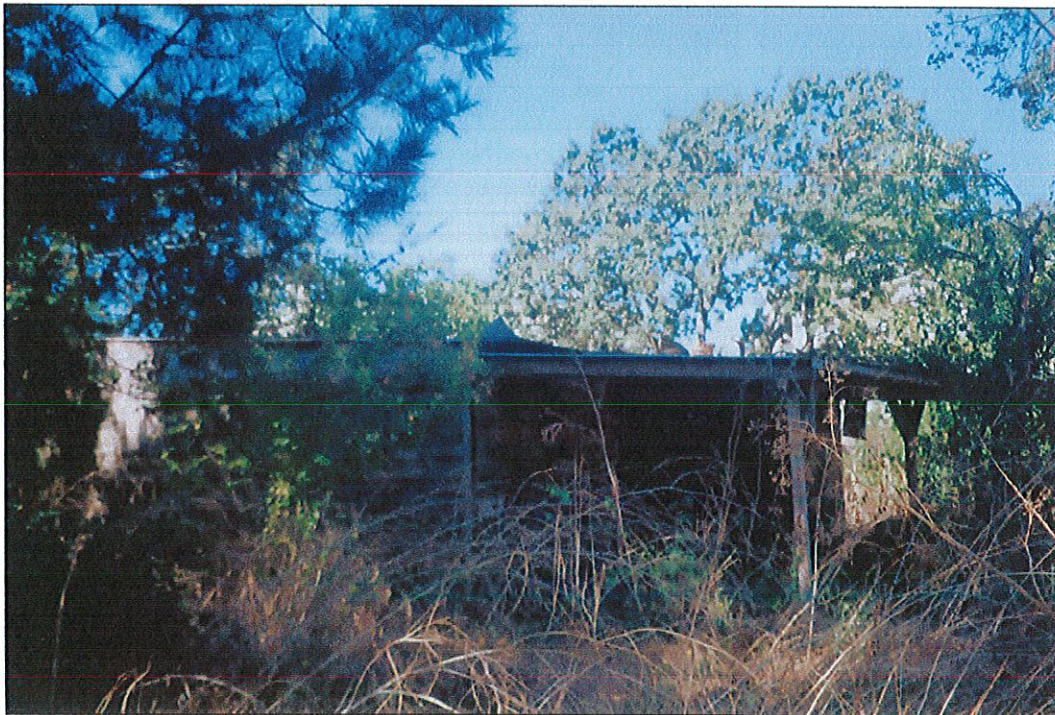
Figure 13: Views of machine shed

This structure is rectangular in shape, oriented east-west on the site. It features a shed roof, wood-frame construction and wood siding. It is in fair condition.

View of shed from front

View of shed from rear

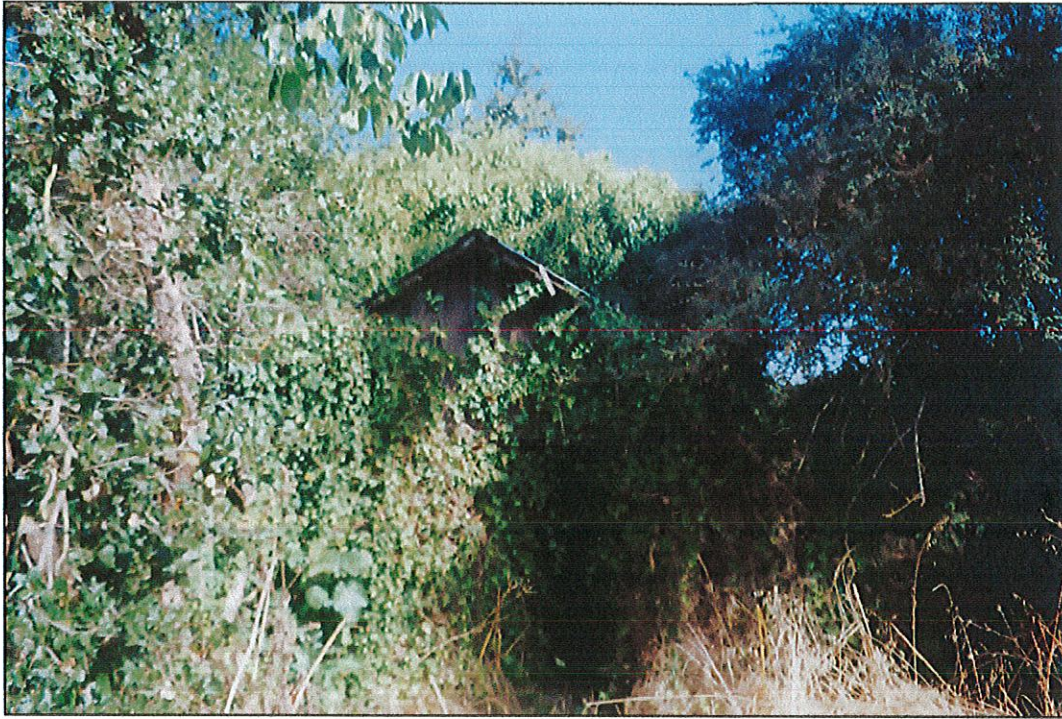
The chicken coop is a small structure to the north of the house, and may be a part of the original farmstead. It is a small, gable-roofed structure, its door facing south, towards the 1898 house. The chicken coop is made up of sawn vertical Redwood boards, about one-and-one-half feet wide and approximately three-quarters of an inch thick. There is no wood framing. Small rafters, narrowly placed, extend from the plate at the top of the walls to the roof ridge. Above this can be seen the original shingles. A corrugated aluminum roof now covers the wood shingle roof. It is in good condition, despite being grown over with vegetation.

Entrance to chicken shed

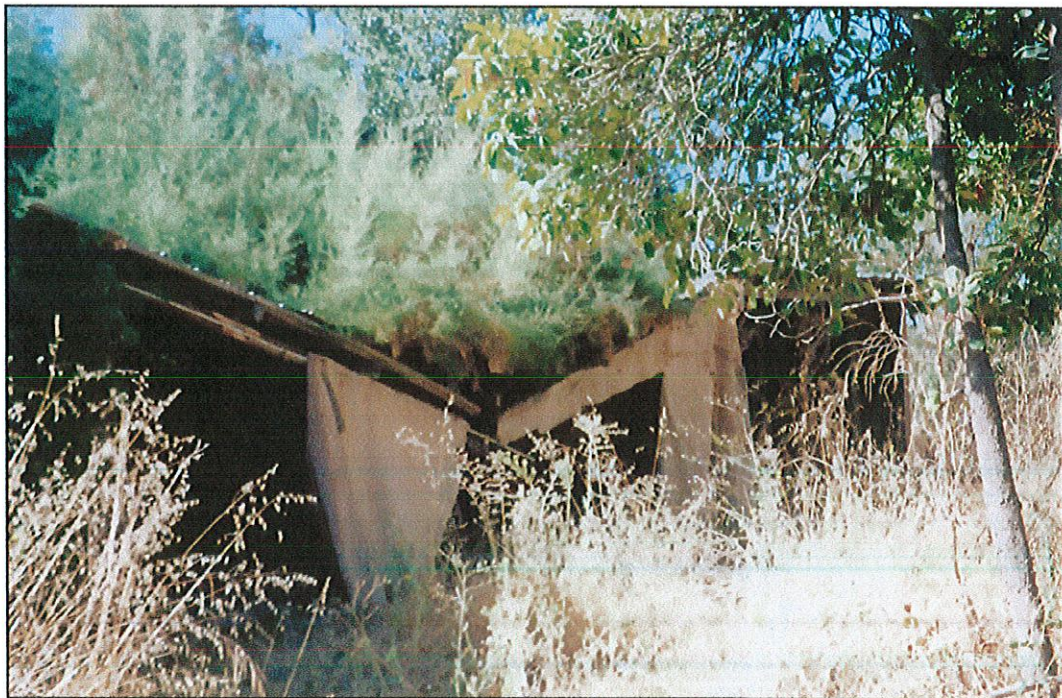
The Dog Run is an open structure just to the west of the Cook Shack. It was added by later tenants. It is a wood-frame structure with plywood siding and a corrugated aluminum shed roof. It is in poor condition. It opens to the rear of the site, to the north. The narrow passageway is located between the Cook Shack and Dog Run, leading to the Chicken Coop and rear of the farmstead.

View of dog run

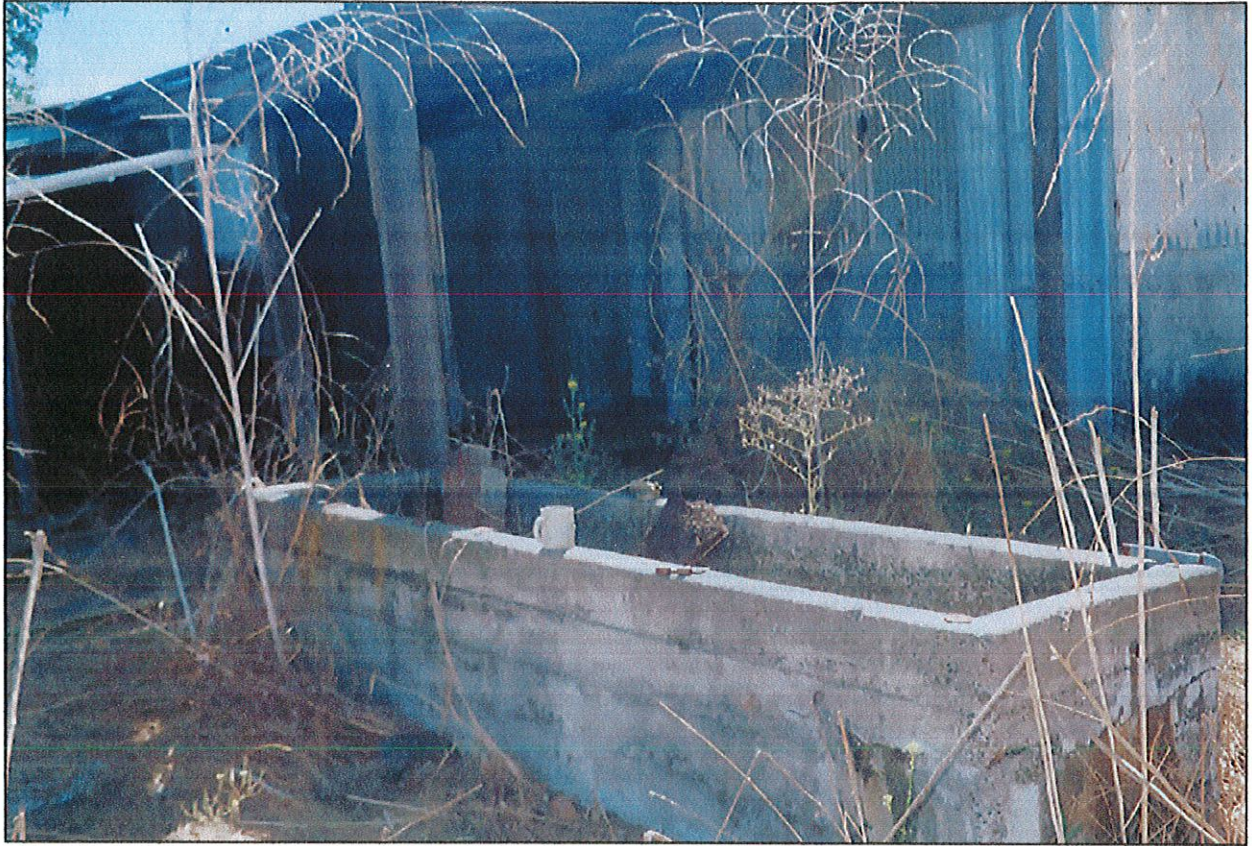
Figure 15: Watering trough

Typically farm landscapes are in a state of continual evolution, and the Irwin Farmstead landscape is no exception. The foundation of the original barn appears at the rear of the farmstead, west of the milking parlor and south of the creek. It appears that portions of the barn had a dirt floor and portions were built on a concrete slab. The barn roof can be seen in aerial photos as recently as the photo in Figure 4. Other features that recall the original function of the farmstead include the concrete watering trough in front of the milking parlor.

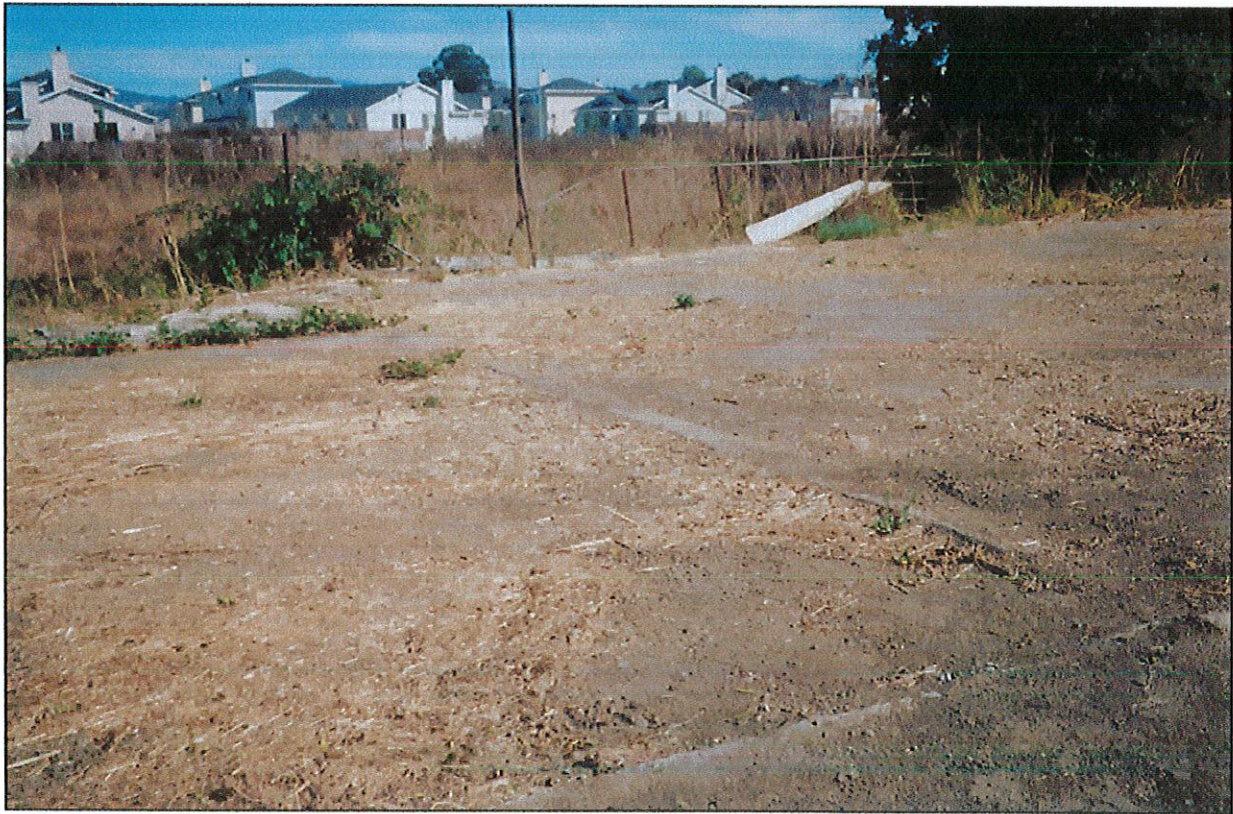
Figure 16: Contextual views of farm

This being said, the integrity of the larger farmstead has been severely compromised. Several of the structures have been allowed to deteriorate and collapse. Some have been demolished. The larger setting has also been compromised. While the farmstead itself retains its integrity in the relationships between the buildings and between the buildings and the immediate landscape, the larger setting has been altered by subsequent development.

View of farm from east

View of barn foundation with development in background
